Manhole Inspection Summary

Manhole # S45A2_004MH

Insp Date: **12/21/07 12:58 PM**

Location Address: **Fairhaven Ave.**

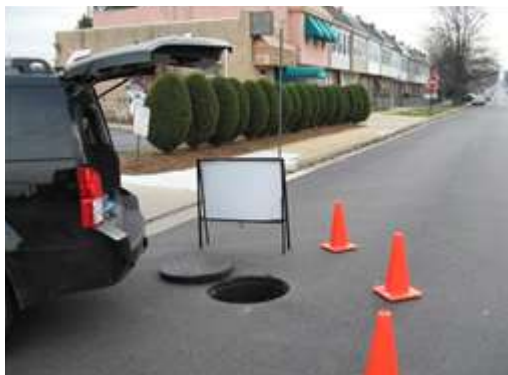
Location View

Fairhaven Ave.

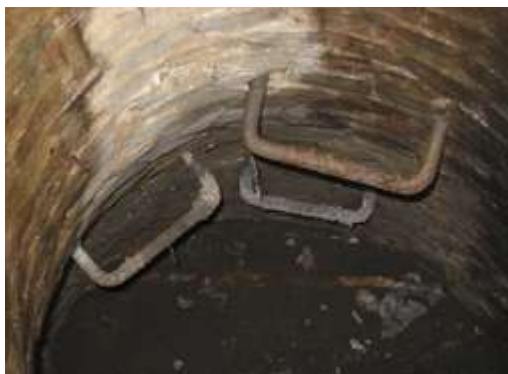
Steps Count: **3** Missing: **0** ☐ Corroded

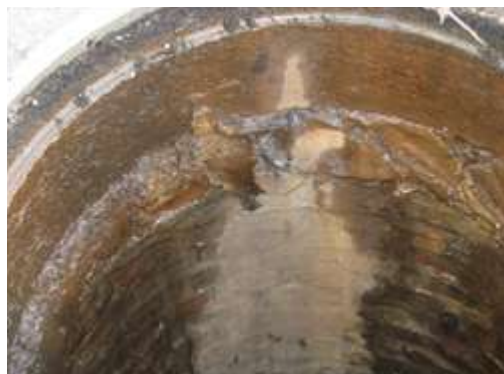
Defect 1

Infiltration: ☐ None ☐ Joint ☐ Cracks ☒ **Mortar** ☐ Roots ☐ Wall

Infiltration

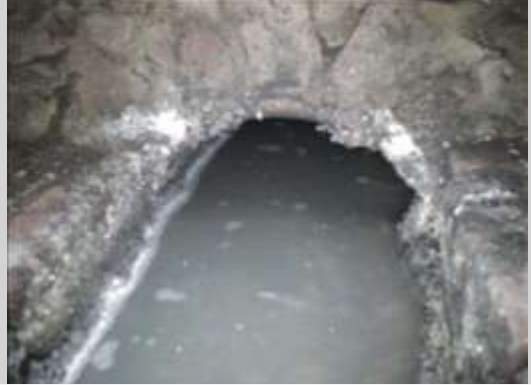
12 O'Clock Outflow

8 in. Circular Gravity Sewer
Pipe Out @ 12 O'Clock

Pipe Height: **12** (in.) Rod and Bar (Angled)
Pipe Material: **Clay** ☐ Pipe Lined
Invert Depth: **9.15** (ft.) Flow Characteristics: **Slow**
Deposits: ☒ None ☐ Mud ☐ Sludge ☐ Debris ☐ Grease
Silt Depth: (in.) Deposits Extent:
Infiltration: **None** Pipe Seal Cond: **Sound**

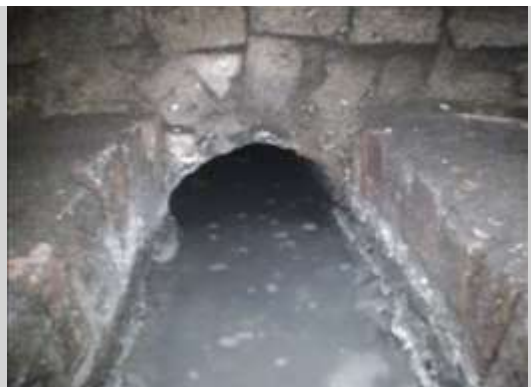
4 O'Clock Inflow

8 in. Circular Gravity Sewer
Pipe In @ 4 O'Clock

Pipe Height: **9.6** (in.) Rod and Bar (Angled)
Pipe Material: **Clay** ☐ Pipe Lined
Invert Depth: **8.97** (ft.) Flow Characteristics: **Slow**
Deposits: ☒ None ☐ Mud ☐ Sludge ☐ Debris ☐ Grease
Silt Depth: (in.) Deposits Extent:
Infiltration: **None** Pipe Seal Cond: **Sound**
